CREAM RIDGE DAM

NJ 00252

PHASE 1 INSPECTION REPORT NATIONAL DAM SAFETY PROGRAM

79 04 05 060
April, 1979

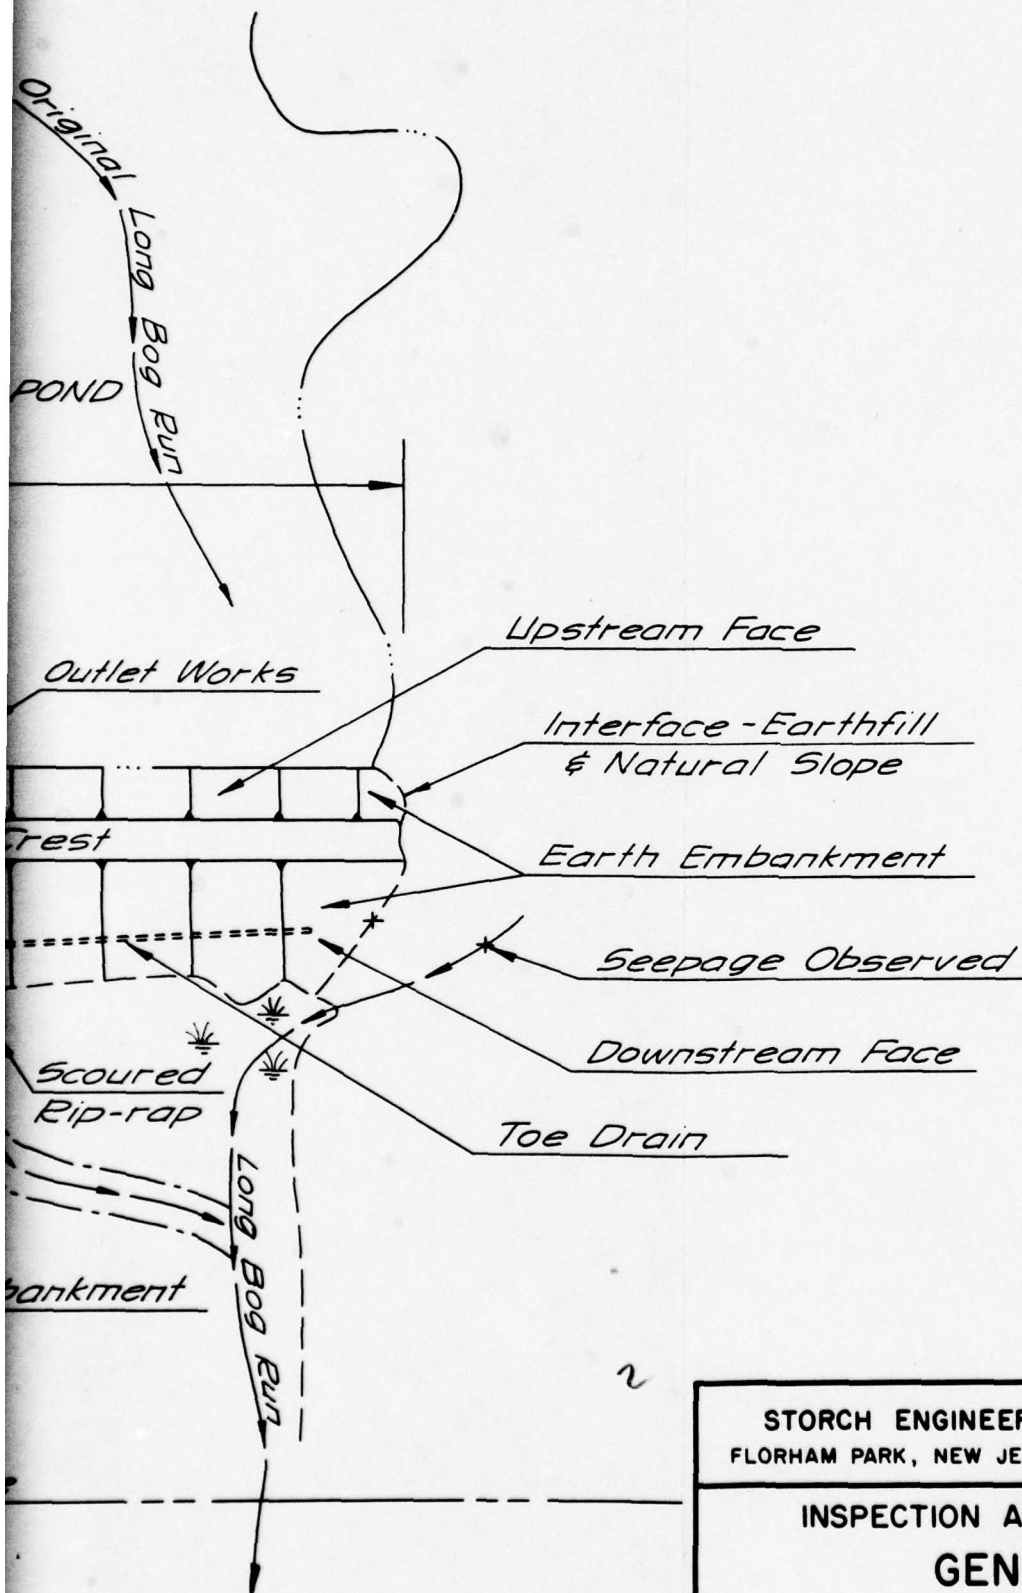
PLATE 4

Two small seepage zones were noted on the south side of the dam during the inspection (see Plate 4 and Photos 8 & 9). The northerlymost zone was located at the interface of the earthfill embankment and the natural embankment. The ground surface in this area was soft and wet at the toe of the downstream embankment slope and up the slope for a height of about 8 feet. This entire area was covered with thick grass.

The upstream portion of the auxiliary spillway was grass lined and in good condition with no signs of erosion. The concrete sill which forms the crest of the auxiliary spillway was grass covered over most of its width and was in good condition. The downstream spillway channel was in good condition down to its outlet where the steep embankment extending down to the natural channel was eroded, (see Plate 4 and Photo 6).

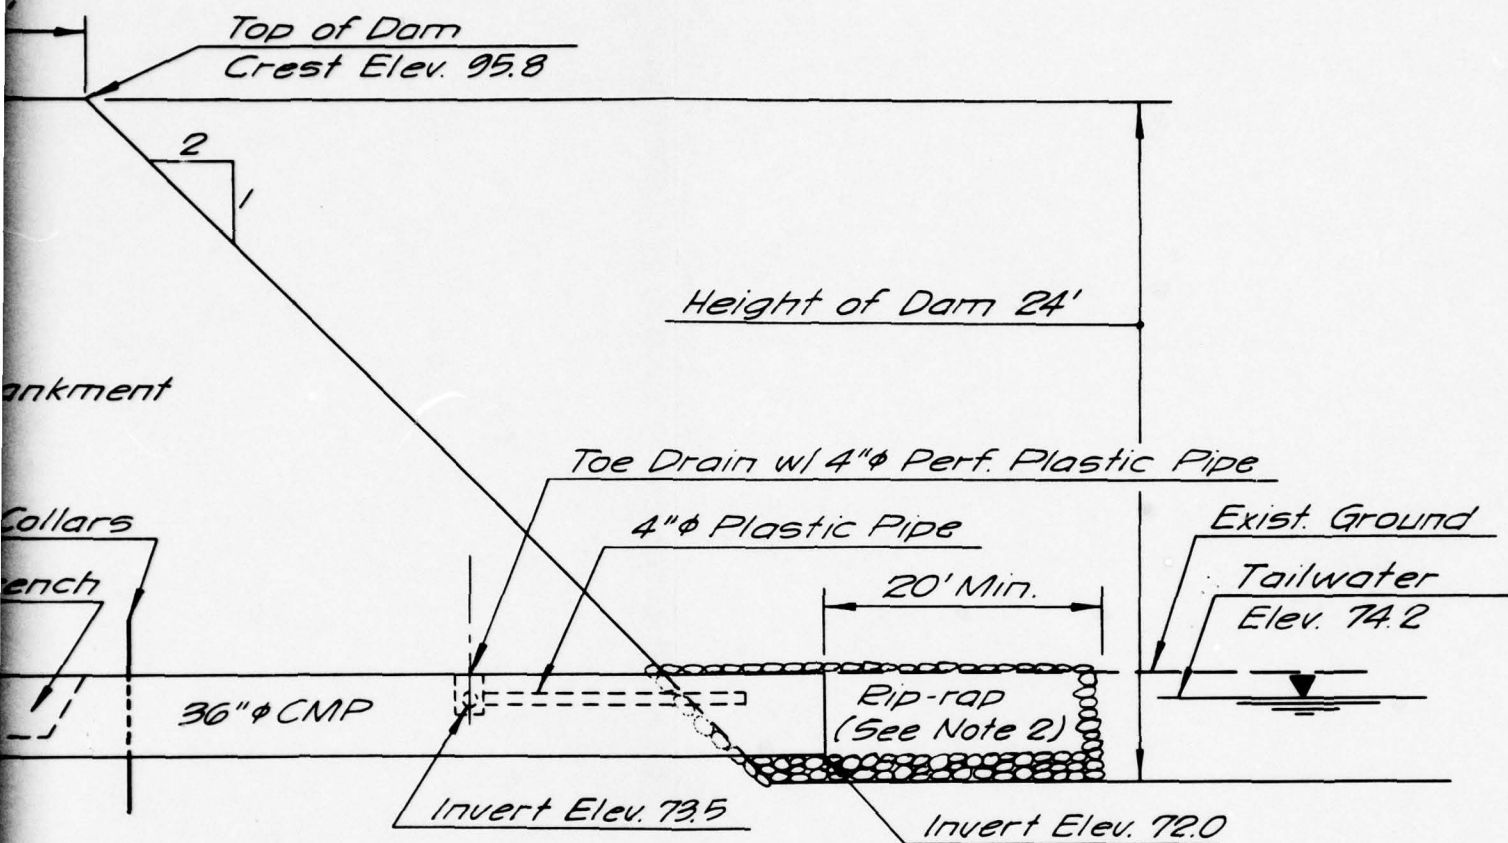
PRINCIPAL SPILLWAY

1. Information taken from "Cross Section of Dam & Spillway" by USDA, Soil Conservation Service and field inspection December 7, 1978.
2. Field inspection indicated that the Rip-rap was scoured.
